# **Mobile Intel<sup>®</sup> Pentium<sup>®</sup> II Processor Specification Update**

Release Date: April 2005

Order Number: 243887-048

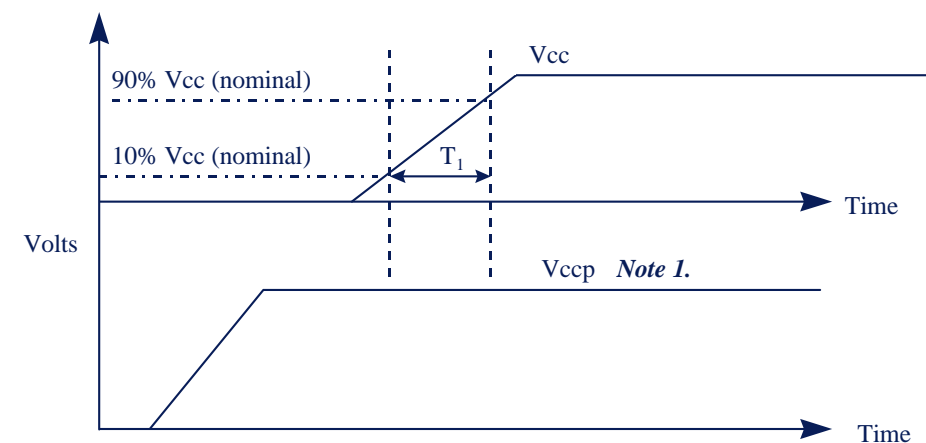
**Figure 1.  $V_{CC}/V_{CCP}$  Timing Requirements (Mobile)**

**Problem:** The processor uses the PWRGOOD signal to ensure that no voltage sequencing issues arise; no pin assertions should cause the processor to change its behavior until this signal is asserted, when all power supplies and clocks to the processor are valid and stable. However, if  $V_{CC}$  ramps up before  $V_{CCP}$ , it will cause the processor to enter an invalid state.

**Implication:** If this erratum occurs, the system may boot normally however, the L2 cache may not be initialized.

**Workaround:** For Mobile Pentium II processors, ensure that  $V_{CC}$  ramps after or with the L2 cache IO voltage ( $V_{CCP}$ ). If  $V_{CCP}$  ramps after the  $V_{CC}$ , a delay circuit can be placed on the core  $V_{CC}$  to ensure that  $V_{CC}$  ramps at the same time or after  $V_{CCP}$  as shown below in Figure 1.

Symbol	Parameter	Min	Max	Notes
$T_1$	$V_{CC}$ Ramp Time	200 uSec		Measured between 10% $V_{CC}$ (nom) to 90% $V_{CC}$ (nom)
<b>Note 1:</b> $V_{CCP}$ must be greater than $V_{CC}$ during the interval in which $V_{CC}$ rises from 20% $V_{CC}$ to 80% $V_{CC}$ .

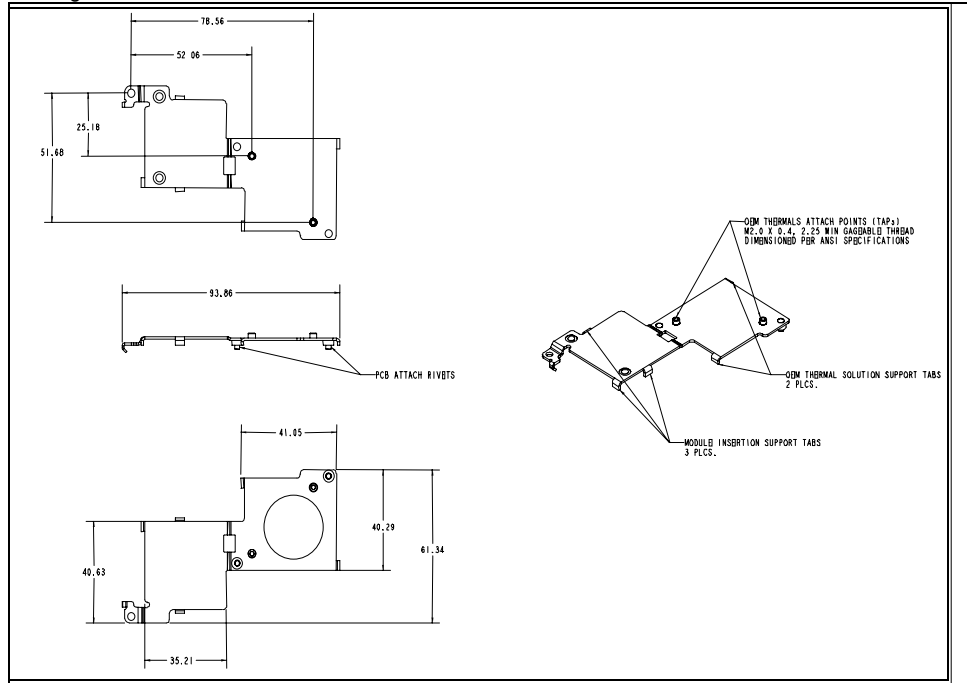
Figure 1. TAP Gageable Thread Clarification

OEM Thermal Attach Points (TAPs) M2.0 x 0.4, 2.25 min gageable thread dimensioned per ANSI specification.
